Manhole Inspection Summary

Manhole # S51C__001MH

Insp Date: **9/15/09 9:31 AM**

Location Address: **Streeper-Linwood Alley**

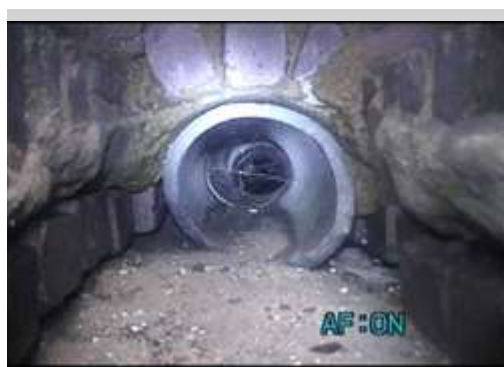
Defect 2

Condition: ☐ Sound ☐ Cracked ☐ Root Intrusion ☒ **Deteriorated** ☐ Leaks ☒ **Debris**

channel deteriorated. does not have the half round bottom that it should.

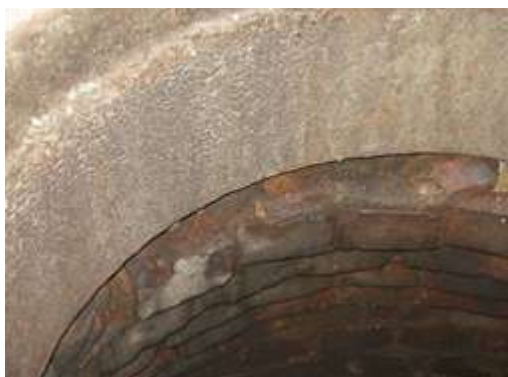
Defect 4

Condition: ☐ Sound ☐ Cracked ☐ Root Intrusion ☐ Loose Brick ☒ **Deteriorated**

Infiltration: ☐ None ☒ **Joint** ☐ Cracks ☐ Mortar ☐ Roots ☐ Wall

deteriorated chimney with signs of infiltration from joint

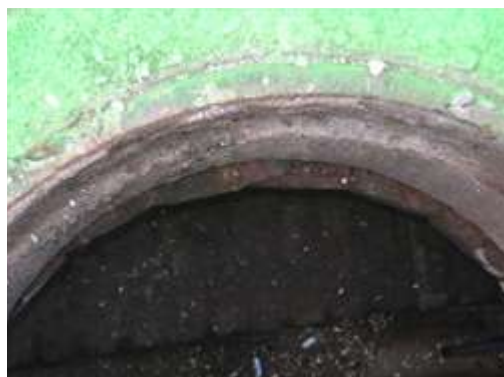
Defect 3

Frame Offset: **1.5** (in.) Condition: ☒ Sound ☐ Cracked ☐ Leaks

frame offset

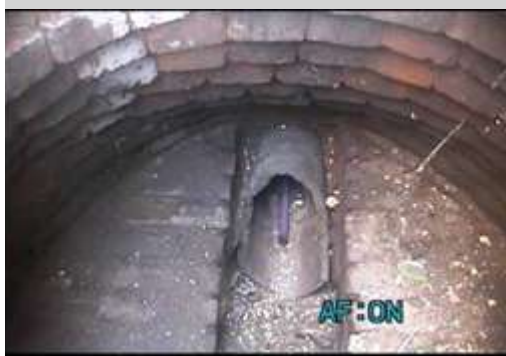
Defect 1

debris in channel

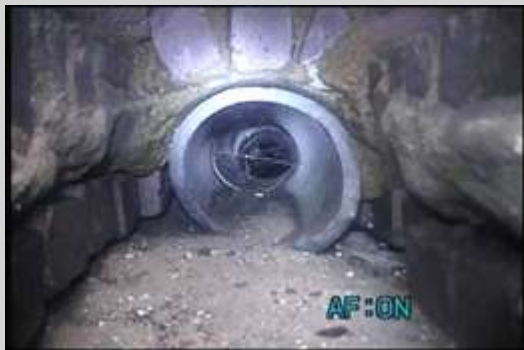
12 O'Clock Outflow

Pipe Height: **6** (in.) Rod and Bar (Angled)
Pipe Material: **Clay** ☐ Pipe Lined
Invert Depth: **3.50** (ft.) Flow Characteristics: **None**
Deposits: ☒ None ☐ Mud ☐ Sludge ☐ Debris ☐ Grease
Silt Depth: **0** (in.) Deposits Extent:
Infiltration: **None** Pipe Seal Cond: **Broken**

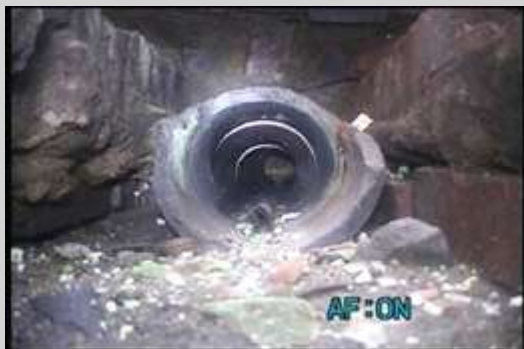
6 O'Clock Inflow

Pipe Height: **6** (in.) Rod and Bar (Angled)
Pipe Material: **Clay** ☐ Pipe Lined
Invert Depth: **3.40** (ft.) Flow Characteristics: **None**
Deposits: ☒ None ☐ Mud ☐ Sludge ☐ Debris ☐ Grease
Silt Depth: **0** (in.) Deposits Extent:
Infiltration: **None** Pipe Seal Cond: **Broken**
